## **CX7 Power Transformers**

TN23

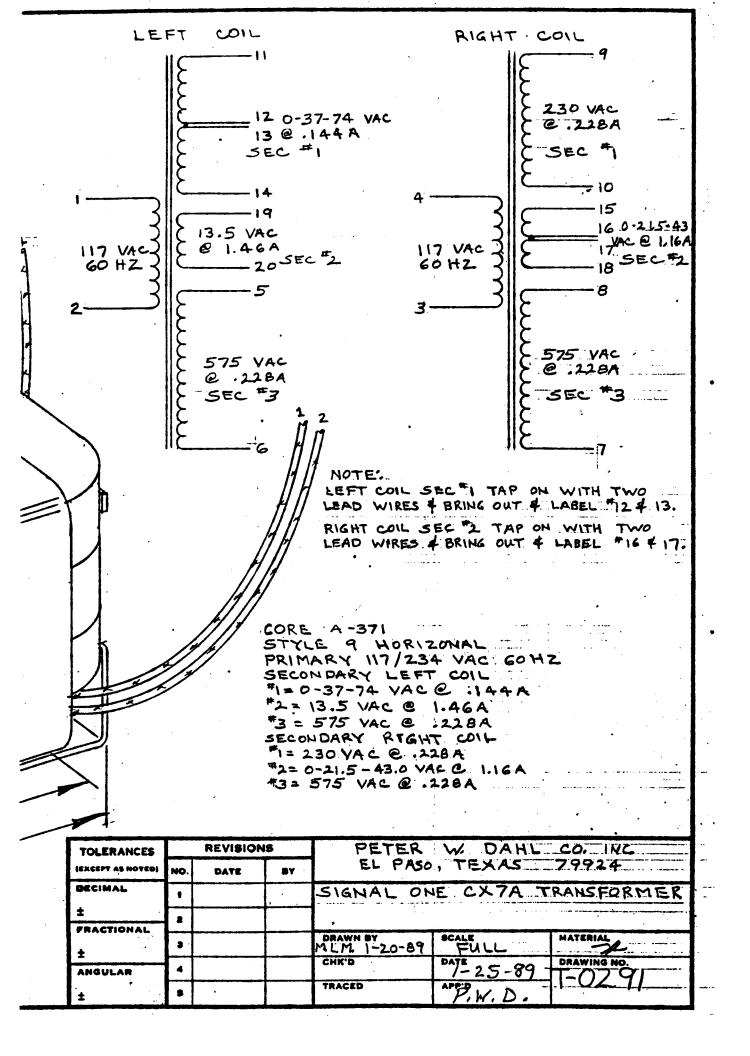
I had a problem with the transformer that I ordered that was not evident until well into the installation process. Referring to the drawing (Fig. ?) you will see a band compressing the transformer. It was incorrectly positioned on the transformer supplied and exceeded the space envelope. This should be checked or a note sent when ordering the transformer.
