SIGNAL ONE

TROUBLE

GUIDE

Revision 10
December 2001

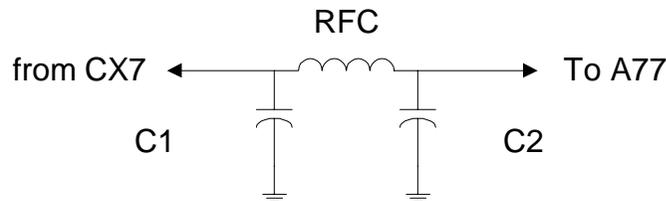
PROBLEM Erratic Alpha 77 operation when being driven with the Signal/One. (For example, A77 cannot be tuned properly on one or more bands)

CAUSE RF is getting into the A77 via the control relay cable to the Signal/One.

SOLUTION Check to see if this is the problem by disconnecting the relay control cable and shorting the relay jack on the rear of the A77. If the problem no longer exists stray RF is the problem. Build the following circuit in a small minibox and insert it between the A77 and Signal/One relay control line.

C1, C2 are .001 1kv disc ceramic
RFC in the range of 10-50 microhys and
able to handle 100 ma.

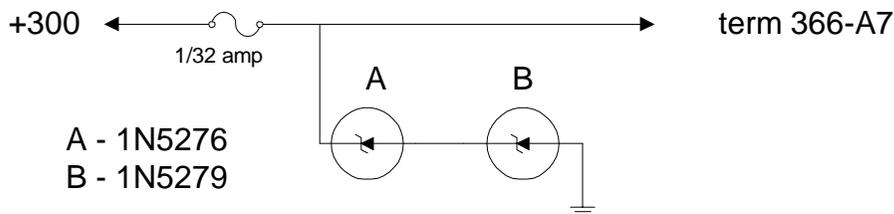
2. Protection for counter board against inadvertent high voltage:

If the +300 volts rises to a high value, the zeners will conduct and force the fuse to blow. (For example if the final develops a plate to screen short, +1500 volts will be placed on the +300 line which will wipe out nearly every semiconductor and tube on A7! If you don't believe it, ask W7IV)

Install the following circuit between the 300 volt supply and the 300 volt terminal on the counter board, A7 (terminal 366):
